INVESTIGATION INFORMATION RELEASE

Death of miner at opal mine

Incident date: 14 October 2020

Event: Fatality in underground opal mine

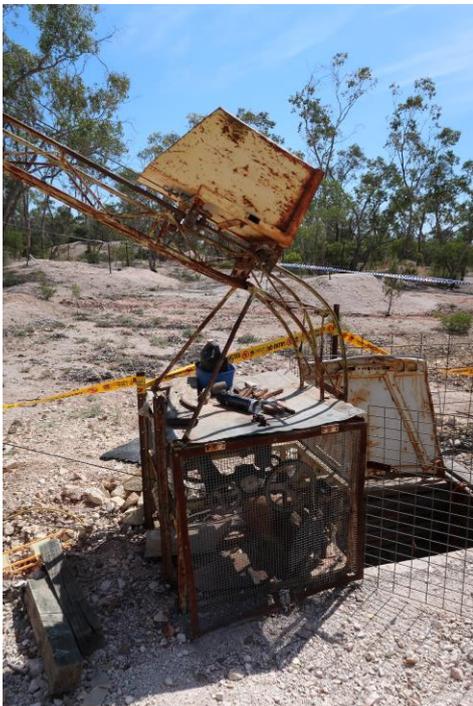
Figure 1 Hoist bucket and motor system at the opal mine

The investigation is considering whether any malfunction of the hoist materially contributed to the incident.

Mine operators must ensure that material hoisting systems are functioning correctly and understand any design or functional limitations. If work is to be undertaken in a shaft, the material hoist bucket must be secured, either at the bottom of the shaft or at the surface, with the hoist system isolated and protective guarding installed to prevent the bucket or other items from falling down the shaft. Workers should not undertake any task in a shaft under suspended or unsecured shaft equipment.

Material hoists are not designed to carry people or have people working directly underneath the material hoist bucket.

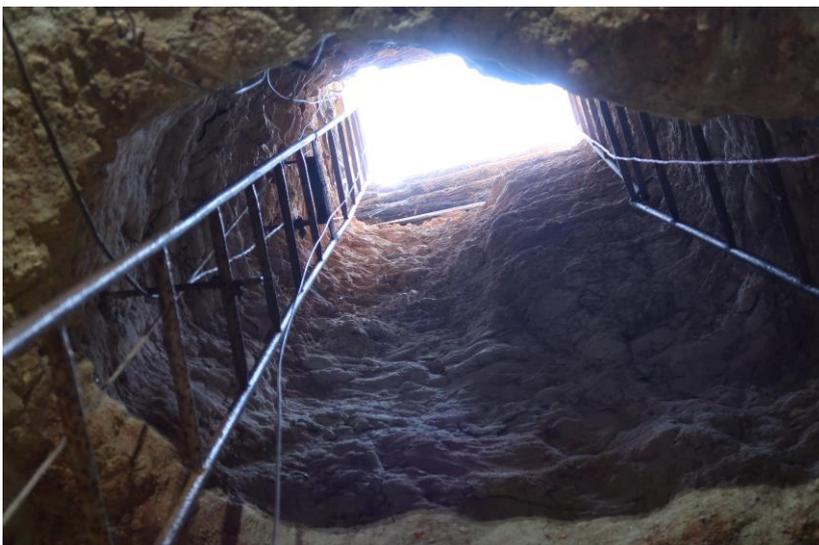
Figure 2 Material hoist shaft at the opal mine

The NSW Resources Regulator has commenced an investigation to determine the cause and circumstances of the incident. While the investigation is still in its preliminary stages, it is suspected that Worker A may have fallen down the shaft while attending to the malfunction of the hoist and bucket.

It appears that Worker A may have been wearing a hard hat, but there is no evidence that he was wearing a safety harness or using any other fall prevention equipment.

Mine operators accessing a mine using a shaft must ensure they have considered the risks and implemented measures to prevent falls. Where falling is not preventable, miners must implement measures that mitigate the impacts of a fall (such as the application of fall restraint/arrest systems). If a ladder is used for access it must be fit-for-purpose and regularly inspected.
